Reliability Assessment for NanoEngineered Fatigue Crack Sensor

IWSHM-2017

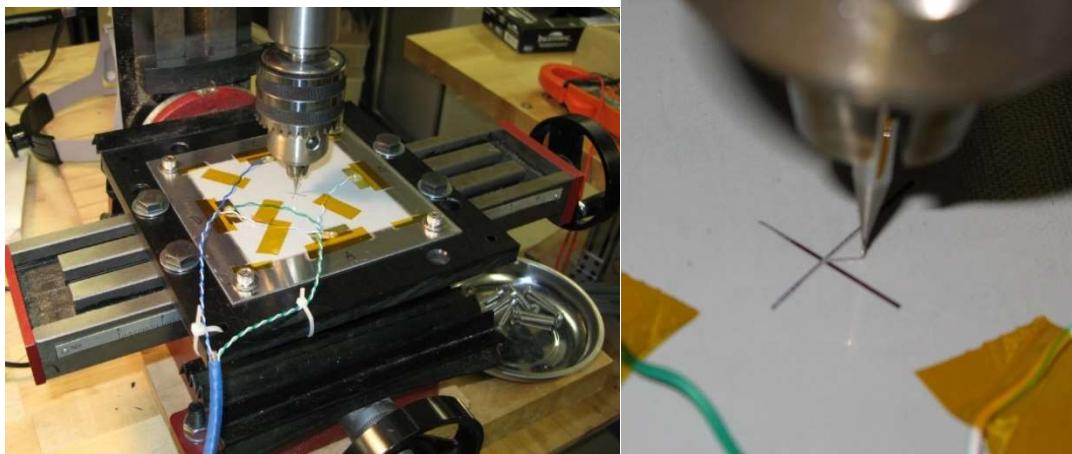
Figure 2. Various photographs of the experimental setup for calibrated flaw detection

An experiment was devised to predict the extent and orientation of a growing flaw. The specimens were 15 cm square 7075 aluminum 1.5 mm thick plates to be representative of aircraft skin. First a 10 cm piece of adhesive film was placed in the center of each specimen. Next a 7.5 cm square piece of CNT sheet was placed over the film. Metal mesh was then placed in the center of each of the sides, 6 mm of overlap on CNT and 12 mm of overlap just on adhesive film. The width was picked used the previously described model as a good balance between sensitivity and coverage across the area based on the shape of the resulting electric field. A piece of surfacing film was placed over the CNT and overlapped mesh, and this entire assembly was vacuum bagged, debulked, and cured at 120°C for 2 hours

Each specimen was loaded into a custom fixture to support it in a milling machine. A 0.5 mm carbide end mill was used to simulate crack growth in a specified orientation. First the end mill was plunged into the center of each specimen to create a 0.5 mm hole that was 1 mm deep, removed and data was collected. Next the end mill was returned to the hole and moved 0.5 mm at a time using the precision stage to extend the crack, while maintaining a 0.5 mm width and 1 mm depth. After each step the bit was retracted and data collected, and this process was repeated for a maximum flaw of 6 mm long. Two specimens were machined with cracks parallel to 2 sides, and two specimens were machined with a crack growing along the diagonal.

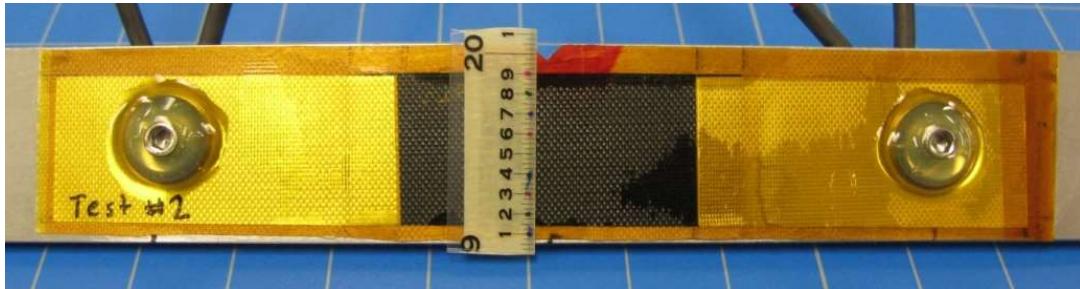
Figure 5. Various photographs of the experimental setup for calibrated flaw detection

Each continuum crack gauge was built by sandwiching a sheet of CNT between layers of adhesive and electrically insulating films. The extremes of the CNT overlapped with an electrically conductive film that further contacted electrodes to monitor specimen resistance after each fatigue cycle. The sensor was a total of 150 micron thick with an active testing area of 5 x 2 cm. The cured CNT gauge was then bonded to a 6061-T6 Aluminum bar (30 x 2.5 x 0.3 cm) that had been wet sanded with 220 grit sandpaper and cleaned with isopropanol. Micro Measurements epoxy AE-10 was selected to bond the CNT gauge as it is commonly used for strain gauge installations. A notch was milled into each bonded coupon to initiate the fatigue crack. The notch was located in the center of the bar and extended 1.5 mm into the aluminum. The CNT region was set at 3 mm away from the bar's edge in order for the milled notch to end prior to the CNT.

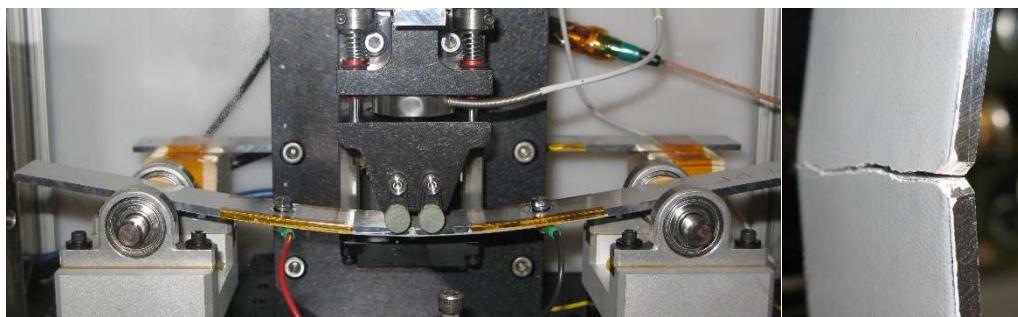
A custom designed 4-point bend test rig was built to cycle each specimen using a precision stepper motor to propagate a fatigue crack. Each specimen was fatigued at 80% yield strain, achieved by a center roller displacement of 7.5 mm, for approximately 50,000 cycles to grow the crack at least 5 mm. The CNT gauge resistance was monitored after each fatigue cycle. During testing, an optical microscope (AmScope MU1000 series) was used to visually follow the crack. A Precision Clear Flexible Film Transparency Ruler by Ryan Precision Controls Products was attached to the crack gauge specimen to monitor crack growth and location. The ruler had minor tick marks 125 micron apart and major tick marks 625 micron apart. Different colored marks drawn on the ruler every 2.5 mm served as reference points to determine crack position along the specimen width. Crack length was monitored every 1,000 to 2,500 cycles during each test. An image of the crack was captured, followed by post-processing crack length measurements.

Figure 6: Photograph of 4-pt fatigue bend fixture (left) and fatigue crack growth (right)
